Troubleshooting

10. What's Wrong?

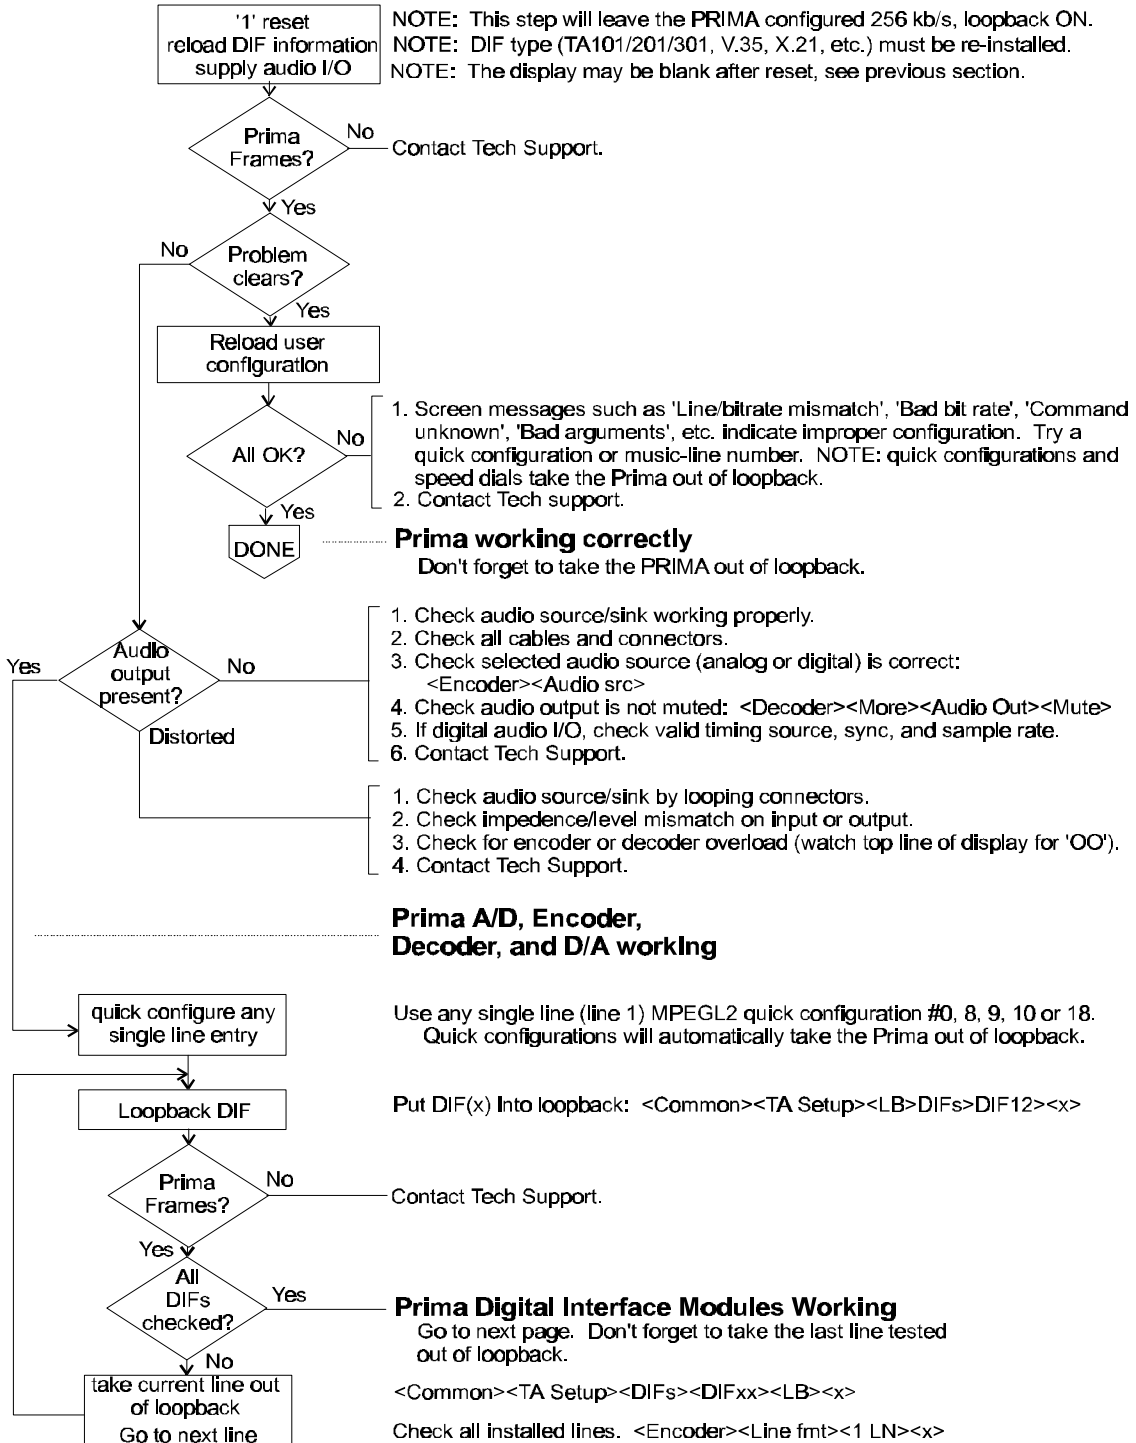
Figure 10-1 - Prima won't frame - No audio output - Prima not responding to commands

See Figure 10-1 for the TA troubleshooting sequence.
