Troubleshooting

10. What's Wrong?

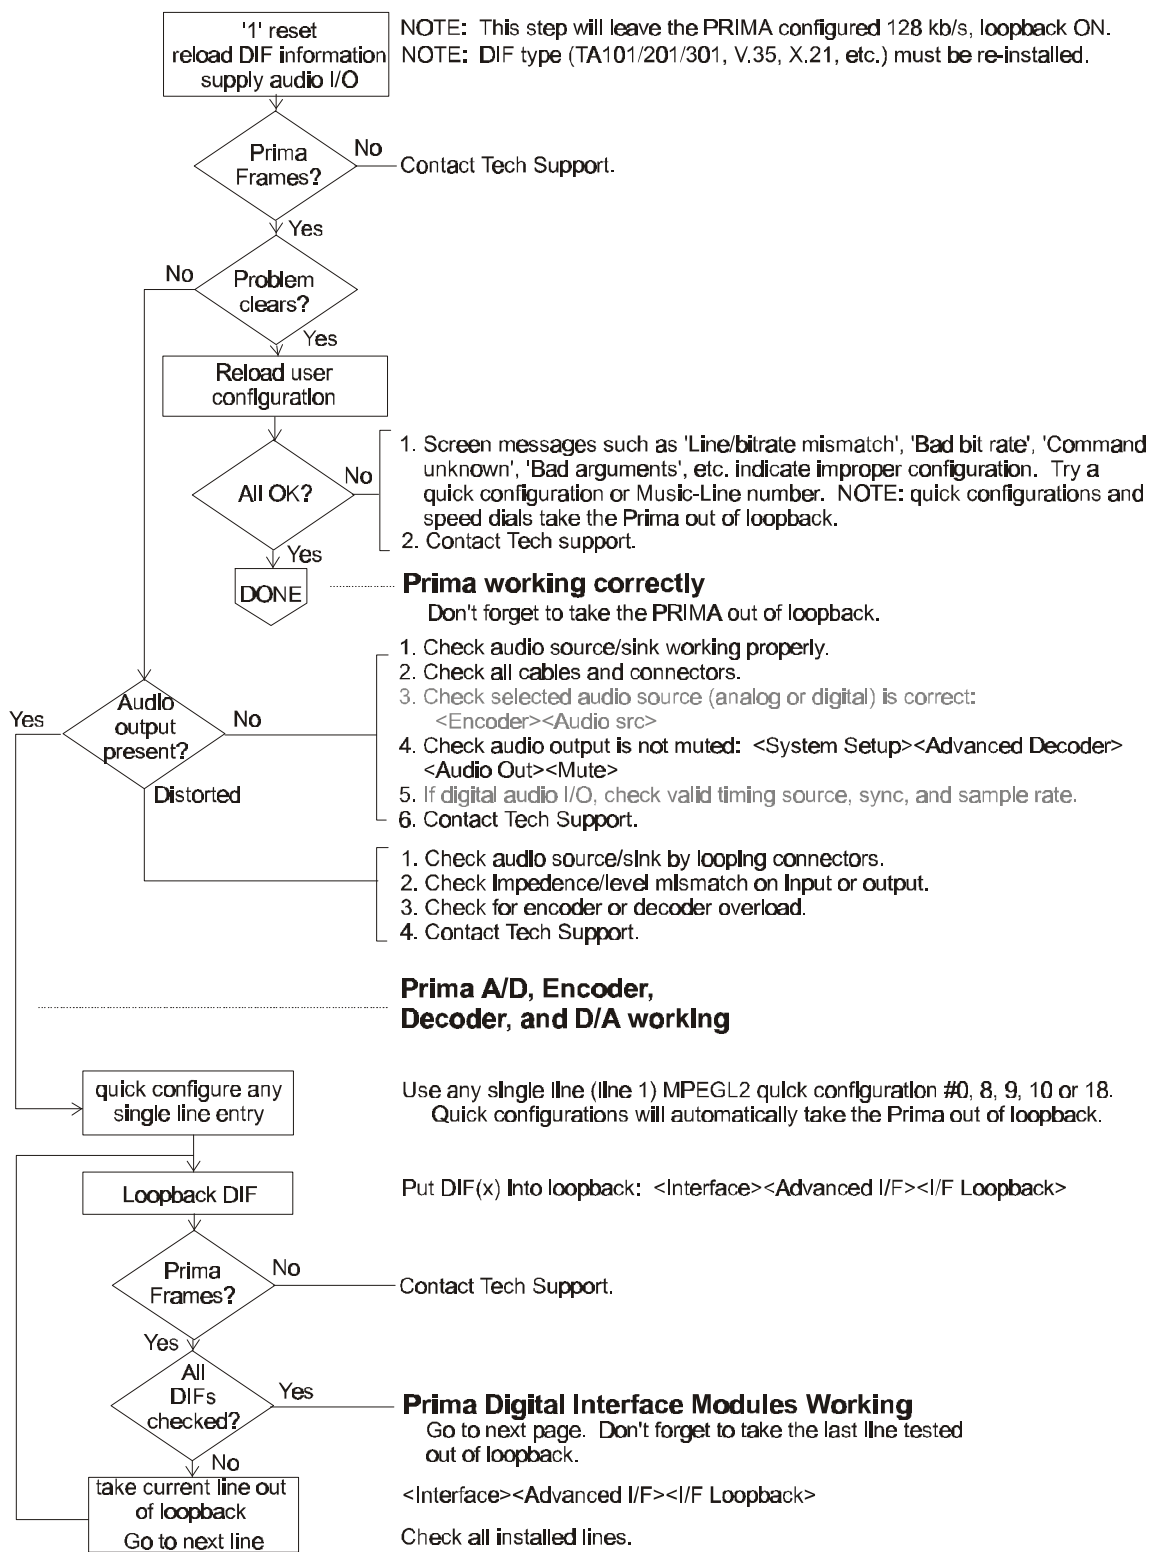
Figure 10-1 - Prima LT won't frame - No audio output - Prima not responding to commands

See Figure 10-1 for the TA troubleshooting sequence.

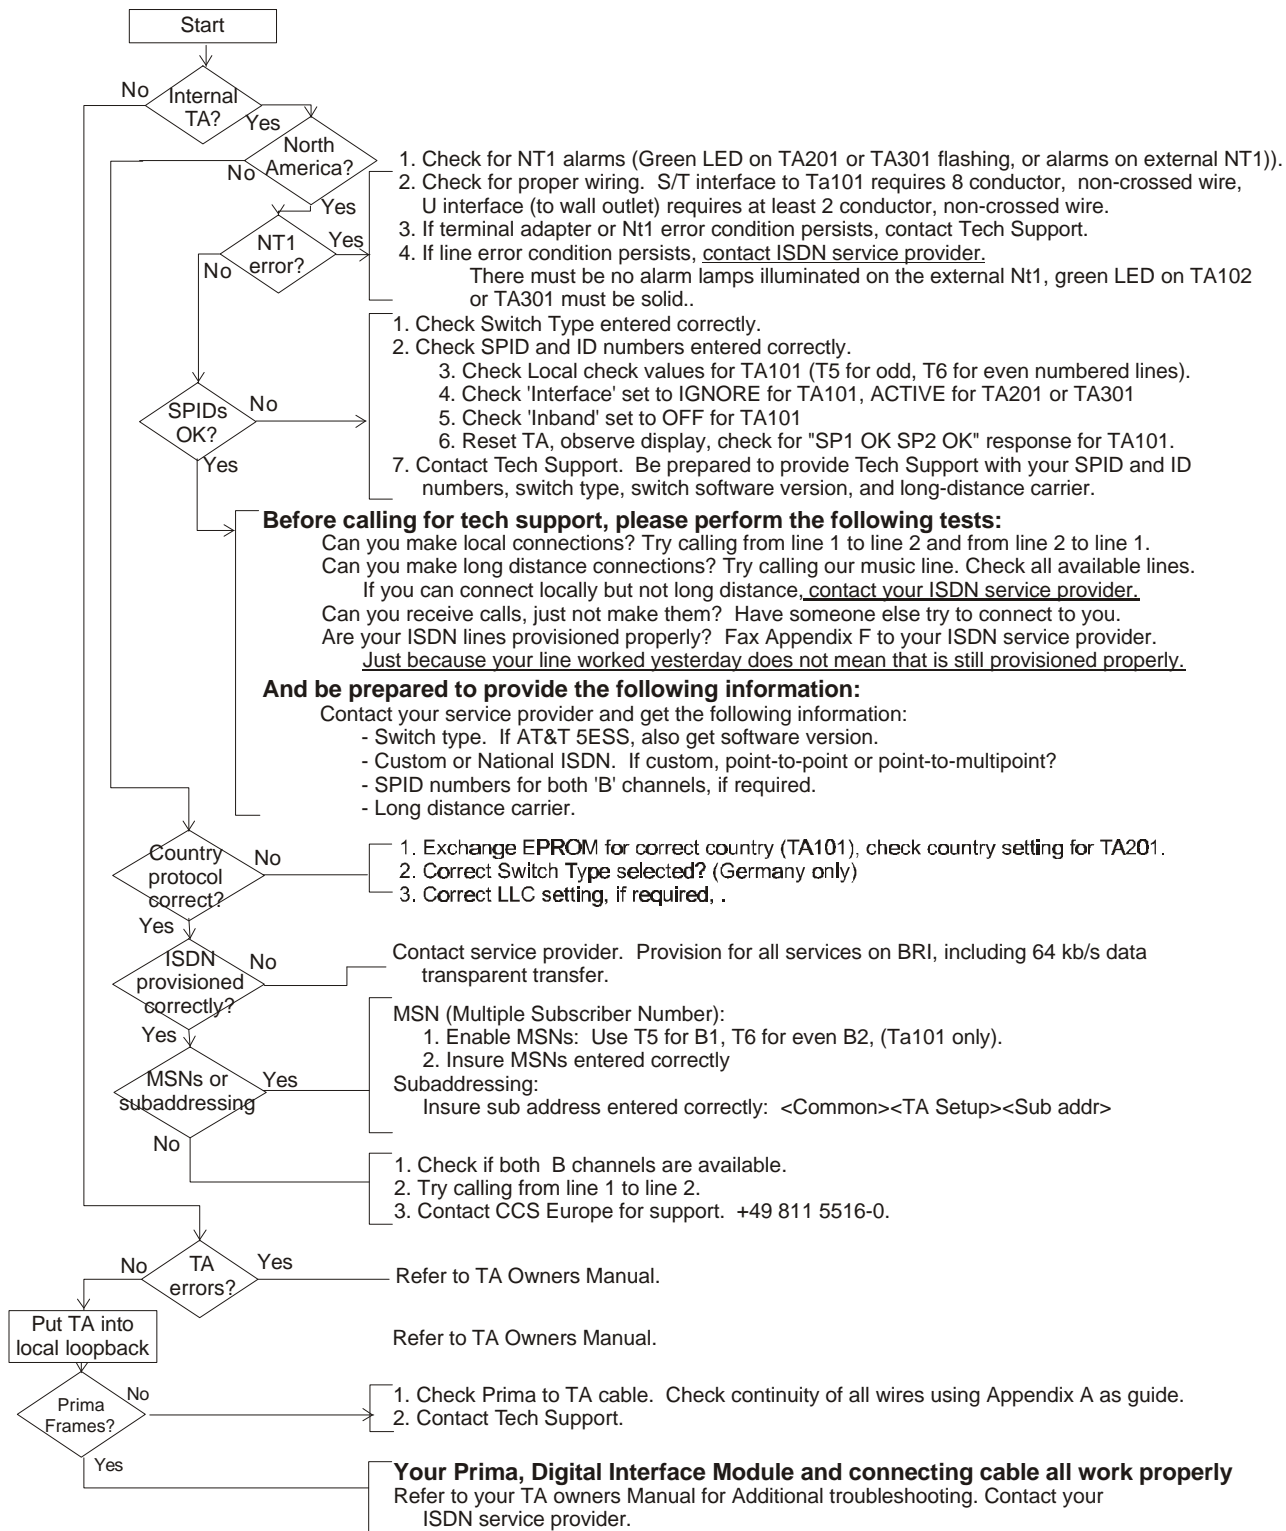
Figure 10-2 - ISDN Connection problems - Can't establish connection on one or more lines
